2018 OHIO RIVER POOL ASSESSMENTS

EMSWORTH AND PIKE ISLAND POOLS

ORSANCO Biological Programs
Ohio River Valley Water Sanitation Commission
5735 Kellogg Ave. Cincinnati, OH 45230
www.orsanco.org

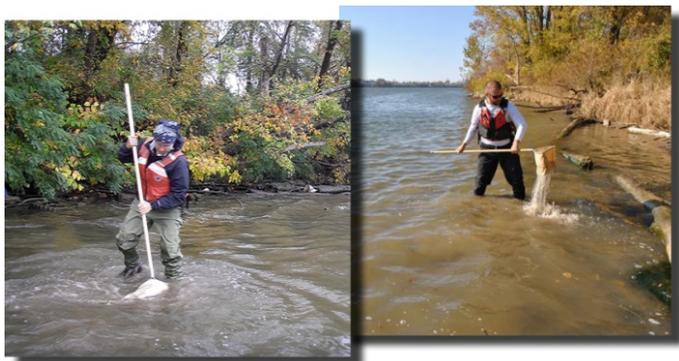
Two sampling methods are used to collect macroinvertebrates (macros): Hester-Dendy (HD) samplers and multi-habitat kicks (MH). HD samplers are constructed of tempered masonite cardboard cut into 3in square plates and 1in square spacers. Eight large plates and 12 spacers are stacked on a metal eyebolt to provide varying degrees of space for macro colonization. Five HDs are attached, in a ring, to a concrete paver. The paver is then placed on the river bottom in 10ft of water at the downstream end of each 500m sampling site and secured to the shore. Similar to the fish, macro sampling is restricted to a defined season within each year. HDs are deployed for six weeks, beginning September 1st allowing adequate time for macro colonization. After the six week colonization period, HDs are retrieved and MH kick surveys are conducted.

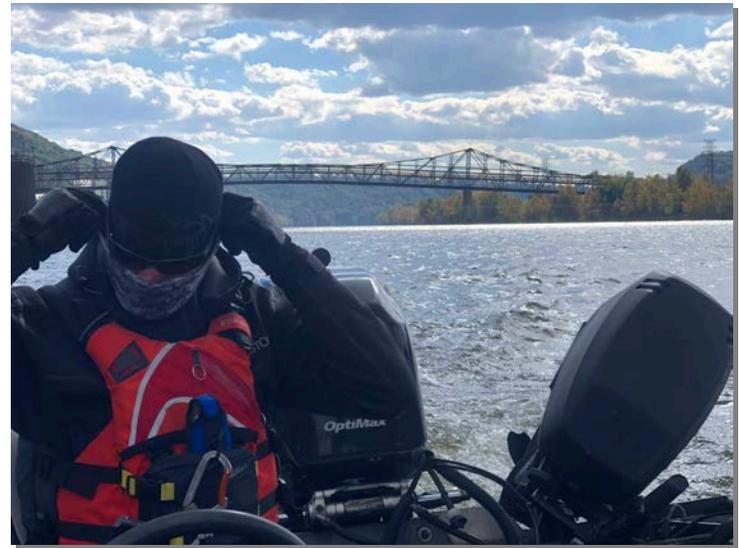
River-wide Assessment Comparison

The 2018 surveys (★) had similar condition ratings to their neighboring pools. Reasons for the variability of ratings across the pools include, but are not limited to varying degrees of anthropogenic land uses (which can affect habitat and water quality), invasive aquatic vegetation, proximity to tributaries (which can affect species diversity based upon the biological condition of the tributary).

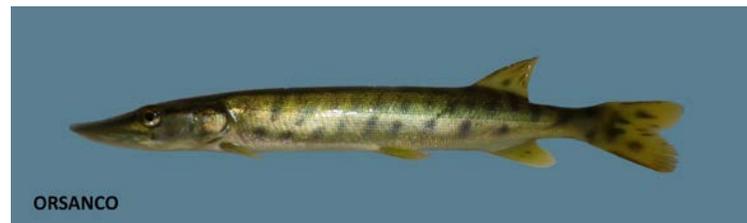
Native Ohio River Fish collected in 2018. Left Top: Silver Chub; Left Bottom: Mooneye; Right Bottom: Muskellunge (juvenile)

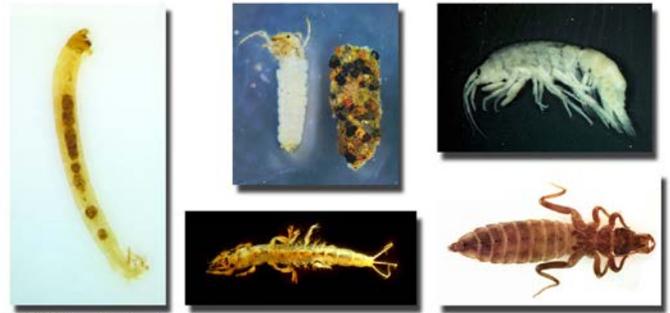
Select Ohio River Macroinvertebrates
Left: non-biting midge (*Tribelos fuscicornis*), Top Middle: long-horned caddisflies (*Oecetis* sp.), Top Right: scud (*Gammarus fasciatus*)
Bottom Middle: burrowing mayfly (*Hexagenia limbata*), Bottom Right: black-shouldered spinyleg dragonfly (*Dromogomphus spinosus*)
